DAMAGE RATIOS FOR DOMESTIC PROPERTY IN THE MAGNITUDE 7.2 1968 INANGAHUA, NEW ZEALAND, EARTHQUAKE

SUMMARY

An analysis of damage costs to domestic property in the M_w 7.2 Inangahua, New Zealand, earthquake of 23 May 1968 (U.T.) has allowed the evaluation of the vulnerability of domestic property for six intensity zones, from MM5 - MM10 inclusive. For no other earthquake worldwide has the vulnerability of any class of property been examined in so many intensity zones, and the effect of brittle chimneys on damage levels has been fully evaluated for the first time. The relative vulnerability of one and two storey houses has also been evaluated. The costs of damage were derived from about 8,000 insurance claims to the Earthquake and War Damage Commission. Damage ratios were evaluated for houses and their contents as functions of Modified Mercalli intensity. The indicators of vulnerability that were determined were the statistical distributions and mean values of damage ratios and the percentage of property items damaged for the six intensity zones. Comparisons have also been made with results from studies of other earthquakes.

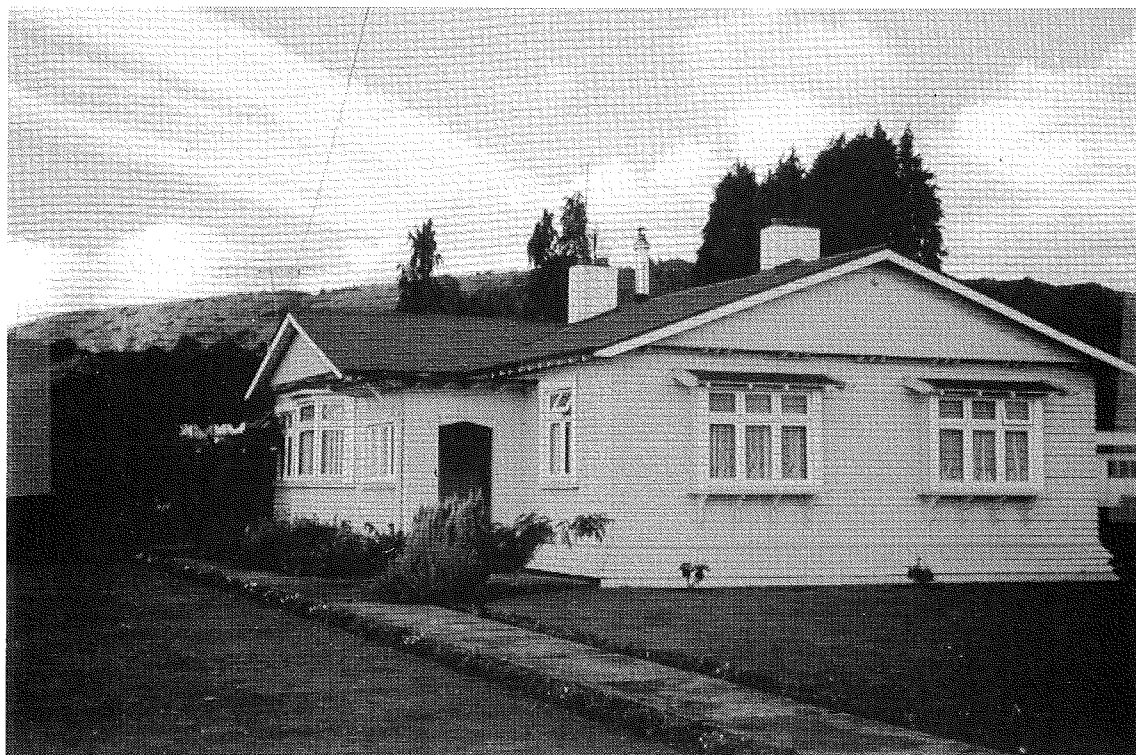
Figure 3(a): The most common type of pre-1968 West Coast house, one storey with a corrugated iron roof weatherboard wall cladding and piled foundations.

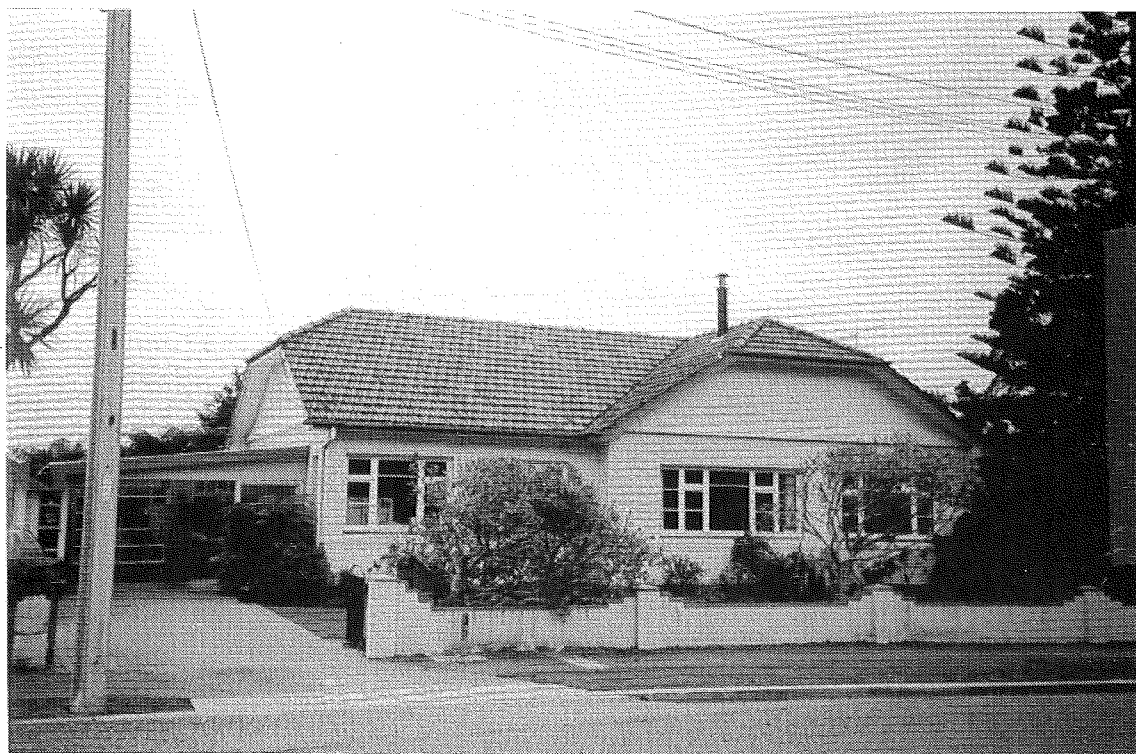
Figure 3(b): A pre-1968 one storey West Coast house with tiled roof, stucco veneer walls and concrete strip foundations.

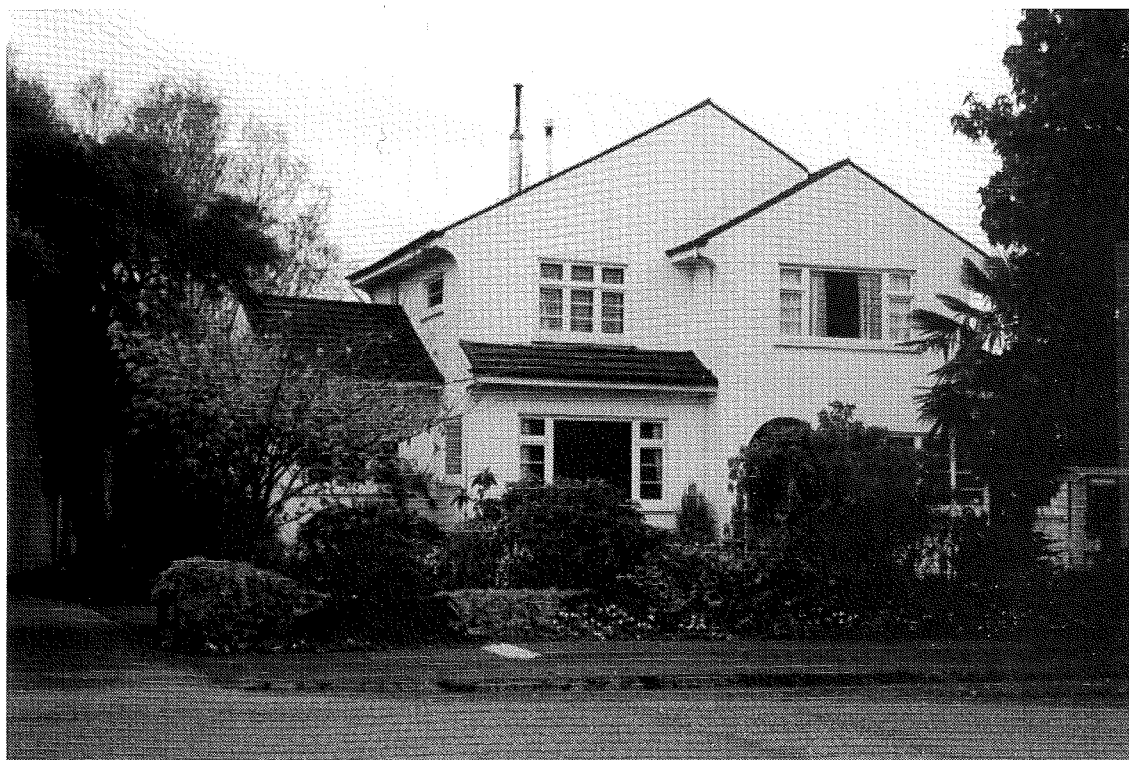
Figure 4(a): A pre-1968 two storey West Coast house with a tiled roof, stucco veneer walls and concrete strip foundation.

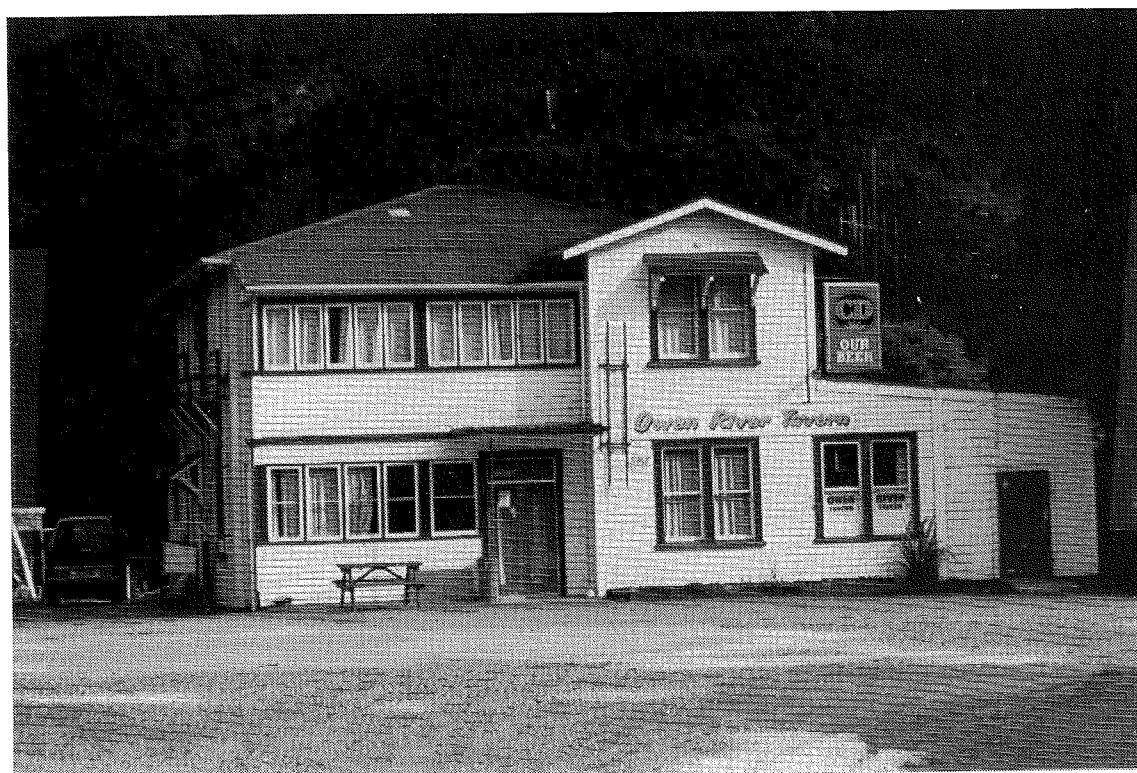
Figure 4(b): A typical pre-1968 two storey hotel of house style construction, with a corrugated iron roof, weatherboard wall cladding and piled foundation.

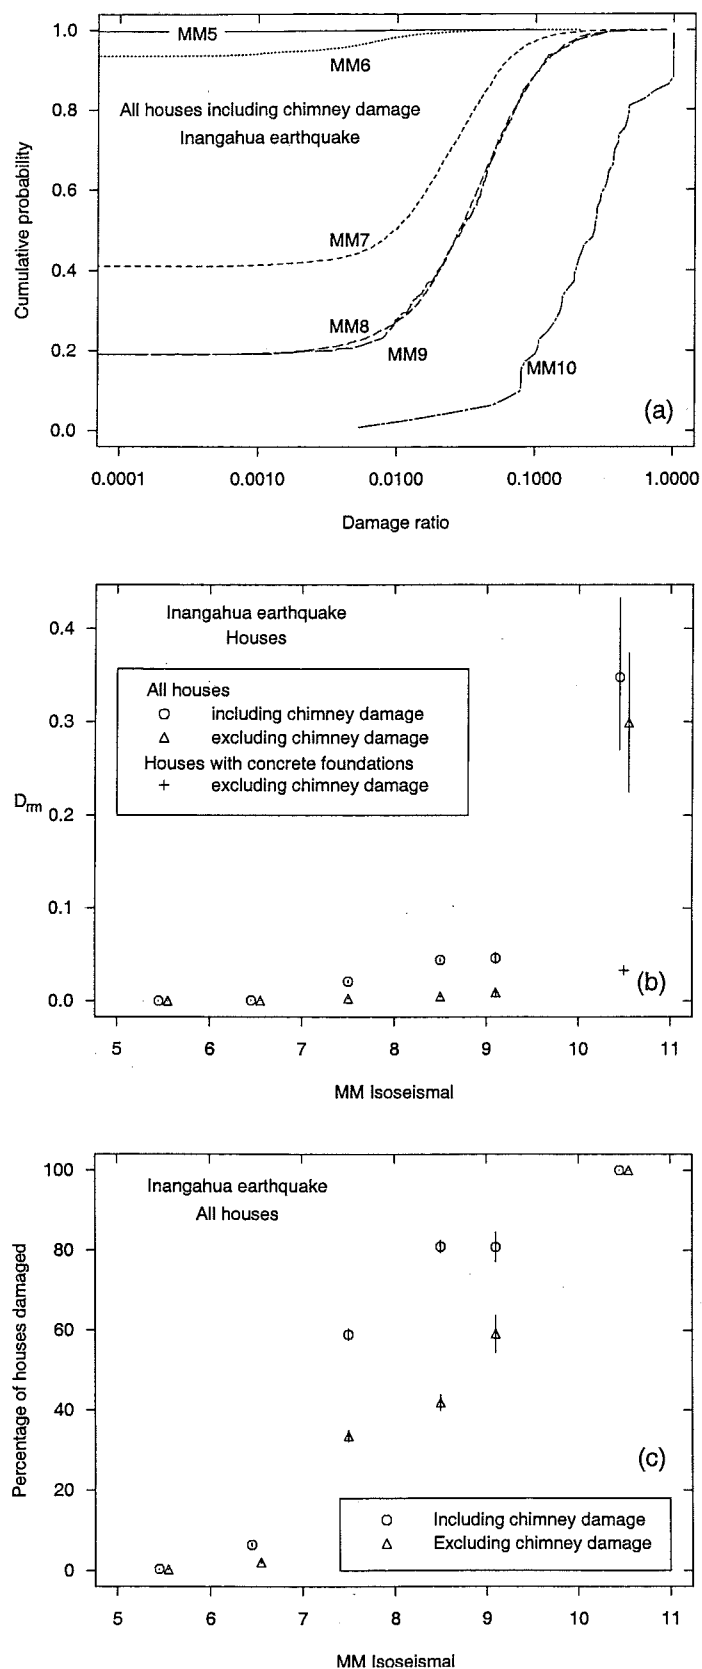
Figure 5: Three measures of vulnerability plotted as functions of MM intensity for all houses in the Inangahua earthquake: (a) Cumulative probability distributions of damage ratio, (b) D_{fm} and its 95% confidence limits, and (c) Percentage of houses damaged with its 95% confidence limits.

Plots of cumulative probability of damage ratios in the Inangahua earthquake are shown for all houses by MM intensity in Figure 5(a). There are six intensity zones, MM5-MM10, i.e. three more than were possible in our richest previous data set [6, 7]. The shapes of the distributions have

the now familiar lognormal form. While very small amounts of damage occur at MM5, Figure 5 shows that the amount of damage is very small and the practical threshold of damage is at MM6 for houses, especially those with brittle chimneys. This is consistent with the definitions of the MM intensity scale [22] (see Appendix 1), and confirms that the outer isoseismals (Figure 1) have been appropriately located.

When considering mean damage ratios, parallel effects are observed to those discussed above in terms of damage ratio distributions. Figure 5(b) shows plots of D_{rm} for six intensity zones. The values of D_{rm} (including all damage) for the Inangahua earthquake range up to 0.35 at MM10.

The remaining key parameter in evaluating damage levels is the percentage of houses damaged, which is plotted against intensity in Figure 5(c) with values ranging up to 100% at MM10. When chimney damage is included, there is a plateau of 81% between MM8 and MM9. These percentages are calculated as n/N from Tables 8, where n is the number of damaged houses including all claims with non-zero costs, where $n = 617, 832, 2961, 2146, 372$ and 55 for MM5-MM10 respectively. When claims below the insurance deductible are excluded the counts of n become $575, 707, 2930, 2133, 371$ and 55 .

definition of the MM intensity scale which states that at MM8 most unreinforced chimneys are damaged and many are brought down (See Appendix 1). This explains the surprising result shown in Figure 5(a), where it is seen that the damage ratio distributions for MM8 and MM9 are virtually identical when all damage is considered. Conversely the expected difference between MM8 and MM9 is seen when the dominating chimney damage is excluded (Figure 6(b)). Figure 6(c) further emphasises the enormous impact of brittle chimneys on the incidence and level of damage, through wide separation of the mean distributions and their 95% confidence limits at intensity MM8 for the cases including and excluding chimney damage.

Next consider mean damage ratio as affected by brittle chimney damage. The influence of chimneys on D_{rm} is very apparent in Figure 5(b) where D_{rm} is seen to range from 2.0×10^{-5} (excluding chimneys) at MM5 to 0.044 (including chimneys) at MM8 and then flattening off to rise only slightly to 0.046 at MM9. This plateau was explained above as a result of chimney damage reaching a near maximum at MM8. The dominance of brittle chimneys as an indicator of vulnerability is also illustrated by the ratio of D_{rm} including chimneys with that excluding chimneys, which in round figures is 1.8, 6, 9, 9, 5 and 1.2 for MM5 to MM10 respectively (Figure 7). The figure of 1.2 for the MM10 zone is close to that of 1.3 obtained for the MM10 zone in Napier in 1931 [8] where all houses also had brittle chimneys, and were of similar construction (weatherboarded and piled) to those of the Inangahua area.

Finally, consider the effects of chimney damage on the percentage of houses damaged, as depicted in Figure 5(c). The ratio of the percentage damaged including chimney damage with that excluding chimney damage is 1.5, 3.2, 1.8, 1.9, 1.4 and 1.0 for MM5 to MM10 respectively (Figure 7). For Napier (MM10 in 1931) [8], as in the Inangahua village area in 1968, nearly all houses had damage other than that caused by chimneys, the above ratio being 1.01. Considering the whole of the affected area (MM5 - MM10), the number of houses damaged would have been reduced by about 45% if no brittle chimneys had existed.

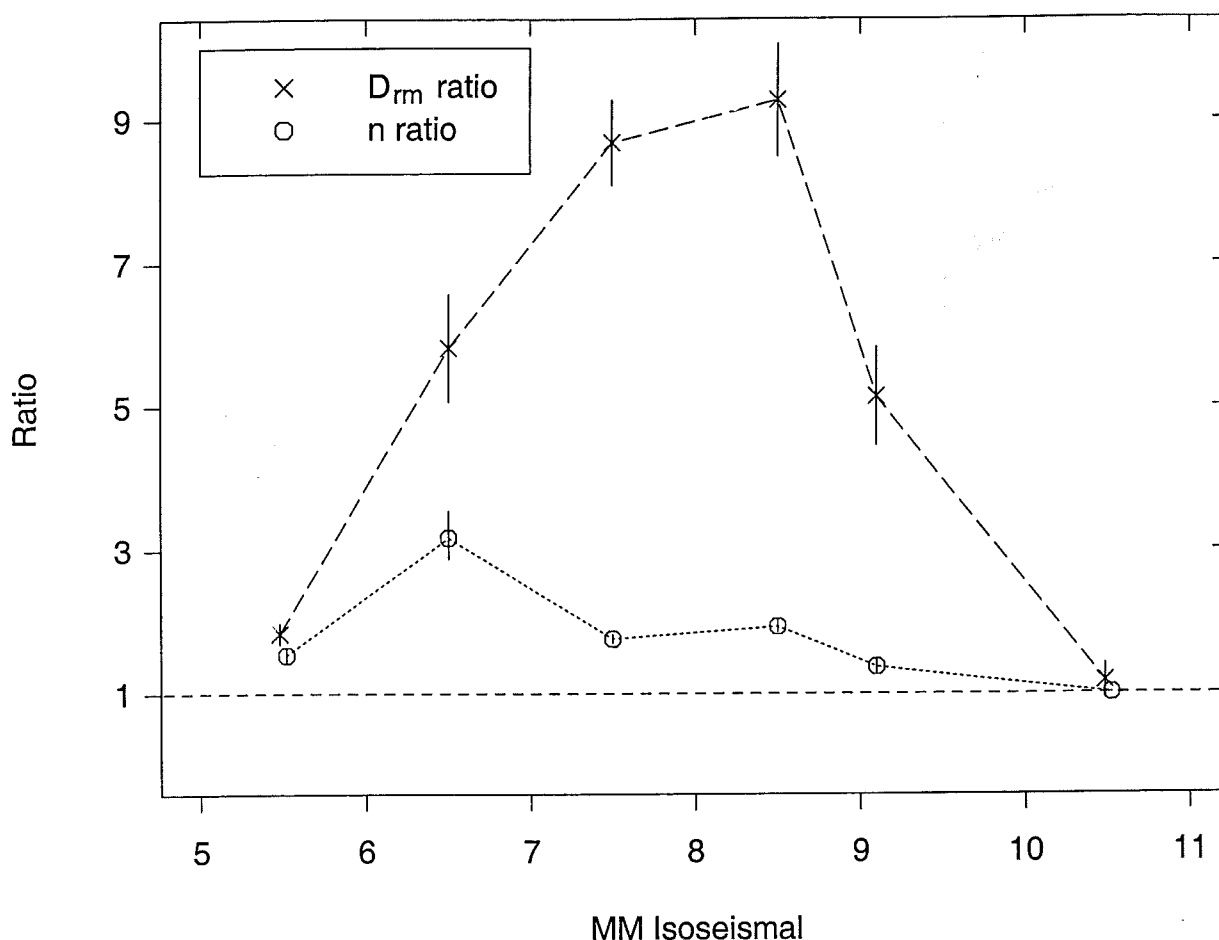
Figure 7: Influence of chimneys on damage to houses as a function of intensity in the Inangahua earthquake. The D_{rm} ratio is the ratio of D_{rm} including chimney damage to D_{rm} excluding chimney damage. The n ratio is the ratio of n/N including chimney damage to n/N excluding chimney damage.

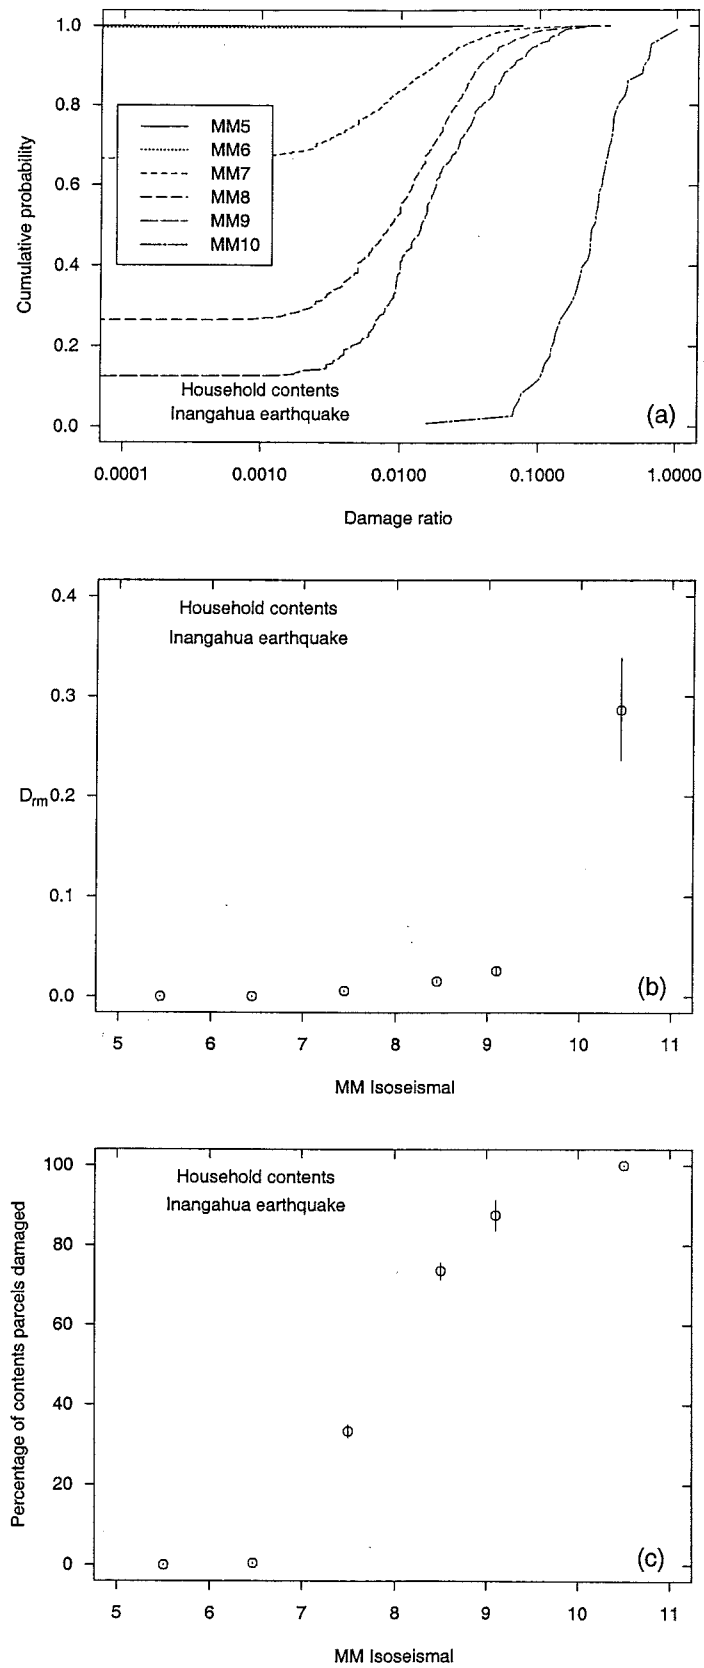
Figure 10: Three measures of vulnerability plotted as functions of MM intensity for household contents in the Inangahua earthquake: (a) Cumulative probability distributions of damage ratio, (b) D_m and its 95% confidence limits, and (c) Percentage of contents parcels damaged with its 95% confidence limits.

Plots of cumulative probability of damage ratio in the Inangahua earthquake are shown in Figure 10(a) for household contents for six intensity zones (MM5 - MM10), twice those (MM7 - MM9) that were possible in the studies [6, 7] of Edgecumbe earthquake. While very small amounts of damage do occur to contents at MM5 and MM6, Figure 10(a) shows that the practical threshold of damage is at intensity MM7 for contents. This is one intensity unit higher than that observed for houses (Section 5.3).

As seen in Figure 10(b), D_{rm} ranges gradually from 2×10^{-6} at MM5 to 0.026 at MM9 before suddenly rising to 0.29 at MM10. This acute non-linearity of D_{rm} with respect to intensity is akin to that of brittle structures. It appears that at MM10 a much greater proportion of household contents is overturned, or is damaged by parts of the buildings, than at MM9.

Finally the vulnerability of household contents is considered in terms of the percentage of contents parcels damaged, as plotted in Figure 10(c). It is seen that the percentage damaged for the Inangahua earthquake rises from very small
